## INTEGRE – Pitcairn Pitcairn – Activity n°2 prevent soil erosion

**Description of Activity:**

- **2.1** : **Erosion control matting**
- **2.2** : **Ground cover plants**
- **2.3** : **Culverts**

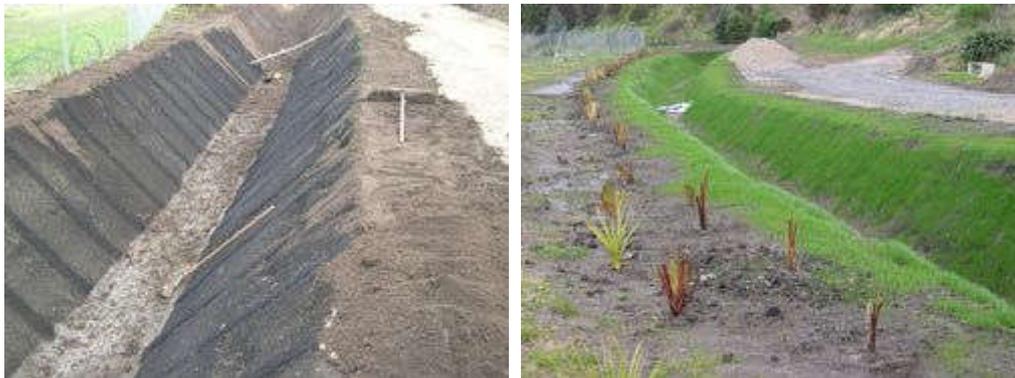
Erosion control matting: the foreseen brand is “Enkamat”: it is a flexible three-dimensional mat for permanent erosion protection on the most varied slope types. These mats offer immediate protection against erosion. The mat’s structure reduces the impact of wind and water on the surface, so it prevents soil runoff.

As a general rule, once laid on the slopes, mats are seeded and covered with humus or topsoil. Vegetation can then take root and develop easily because the mat’s artificial root structure protects the soil and germinating seeds.

*Photo: mats that have been laid on a slope to prevent soil erosion, finished result*

When properly installed, erosion control mats secure exposed and vulnerable soil and prevent rain and wind erosion. Surfaces covered with erosion control mats can later be planted with appropriate ground cover (*reservation lifted from 2014: however this can only take place once the goat population has been acceptably managed and contained*).

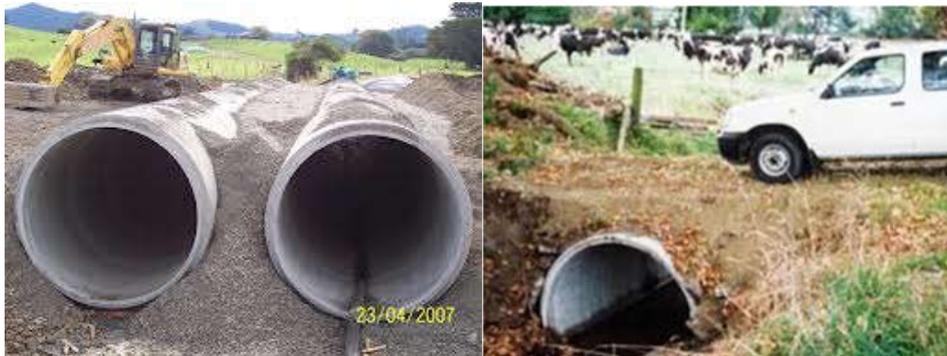
A culvert is a structure that allows water to flow under a road, trail or similar obstruction. Typically embedded into the ground, a culvert may be made from piping, reinforced concrete or other materials.

Culverts come in many shapes and sizes including round, elliptical, flat-bottomed, pear-shaped, and box-like structures. Culverts may be made of concrete, galvanized steel, aluminium or plastic, typically high density polyethylene.

*Examples of culverts*

The culverts will be used to replace and/or reinforce existing bridges and to divert water runoff from the road by directing it underground, thereby preventing washouts, road damage and excess silt flowing into the harbour.

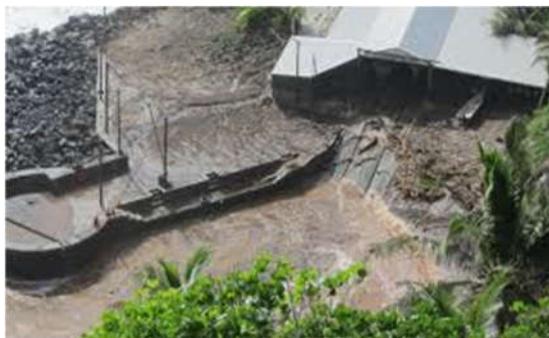
Photo 2. Landslide and debris

In February 2012 Pitcairn experienced exceptionally heavy rainfall of about 600 mm within a 24-hour period. This extreme weather caused several landslides around the island, particularly on the landing road.

The risk of ongoing land slippage above the Hill of Difficulty is quite high, as shown by both recent and historic landslides. The risk of land-slippage under the Hill of Difficulty road, which may undermine the road, is considered slight.
